Fracture Analysis and Repair of Last Stage Blade Reinforcement Boss for Low Pressure Cylinder

Rotor of 330 MW Unit

Abstract: The lace convex table of the final stage blade of a 330 MW turbine fractured. The reason was analyzed by fracture analysis, chemical composition analysis and metallographic analysis. It showed that the overload was the main reason for the fracture. Deformation of guide ring caused by fracture of guide ring bolt was the main reason of the overload. The analysis of the guide ring bolt showed that the brittleness of the guide ring bolt was the main reason for its fracture. It was suggested to strengthen the supervision of the manufacturing process of the guide ring bolt. The lace convex table was repaired by surfacing welding. A reasonable welding process was developed and the repair was successful.

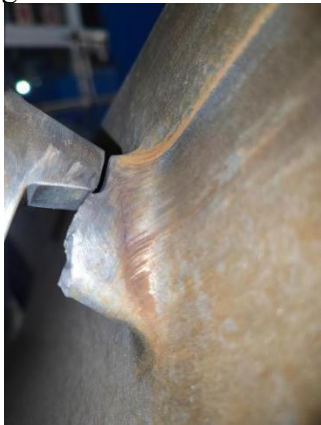
Fig. 1 The tension fracture position of the final stage blade

As illustrated in Figure 1, the tension fracture position of the final stage blade was at the variable section of the boss. Figure 2 displayed the fractured boss, while Figure 3 depicted the macro morphology of the fracture of the boss. In Figure 2, region 1 represented the contact position of the boss between two blades; and the bosses of the two blades will contact during operation. It was also found that the contact position of the fractured boss exhibited distinct crimping which only slight wear should occur in this area under normal circumstances, indicating that the boss had been subjected to excessive forces. Based on the macroscopic morphology of the fracture in Figure 3, the fracture process extended from regions 2 and 3 to region 4. Besides of these, a small number of fatigue lines were observed in region 3 with steps between regions 2 and 3, which suggested a rapid expansion speed. Furthermore, it could be known that region 4 was the shear lip, which was the final fault region.

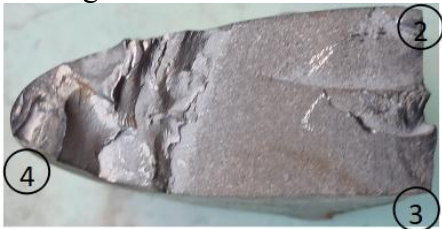
Fig. 3 The macro morphology fracture of the lace convex table

Based on the above analysis, the contact surface of the lace convex table experienced excessive stress, initiating its fracture process with fatigue cracking at region 3 as shown in Figure 3. In

addition, cracking propagates from region 2 and rapidly expanded to region 4 due to the insufficient strength of the surrounding areas.

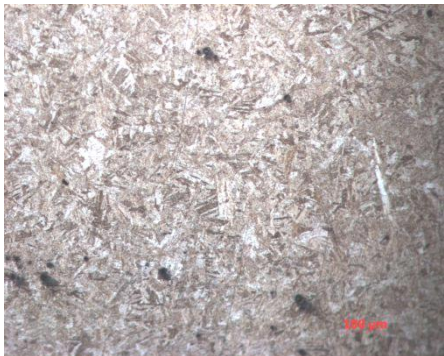
Fig. 4 The micrographs of the lace convex table

In order to get more structural information, chemical composition analysis and metallographic structure inspection were conducted on the lace convex table. As shown in Table 1, there were nothing abnormal could be detected while the metallographic structure (refer to Figure 4) revealed a tempered martensite structure, indicating no abnormalities too.

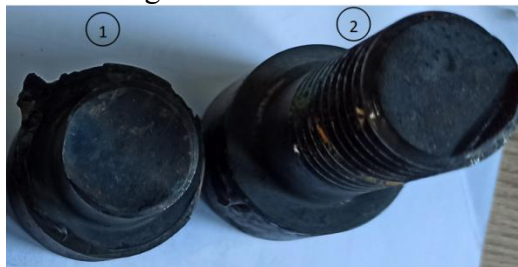
Fig.5 The fractured diversion ring bolt

The fractured diversion ring fixed bolt was selected for further analysis (refer to Figure 5). In Figure 5, the fracture position of bolt 1# was at the junction between the displacement bolt and the thread, while the fracture position of bolt 2# occurred within the thread. Chemical composition analysis and hardness testing were performed on the bolt, and it could be known that the chemical composition meeting standard requirements but the hardness was too high.

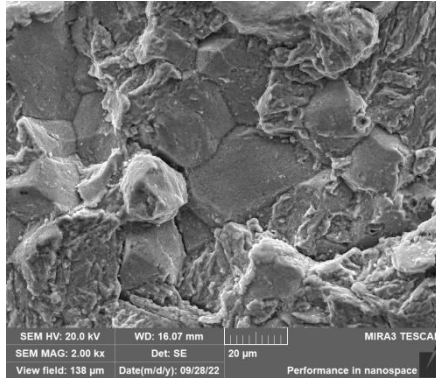
Fig. 6 The fracture of bolt 1#

The fracture was analyzed using a scanning electron microscope. Intergranular fracture, as shown in Figure 6, was discovered in the fracture of bolt 1#, indicating the presence of secondary cracks and high brittleness of bolt. Similarly, it could be observed that intergranular fracture also existed in the fracture of bolt 2# as shown in Figure 7, and the fracture analysis results revealed brittleness as well. The reason for this phenomenon may be attributed to the lack of strict control over bolt processing.
