A Brief Discussion on Technical Points in the Restoration of an Ancient Building in Lanzhou City

3.1 Project Overview

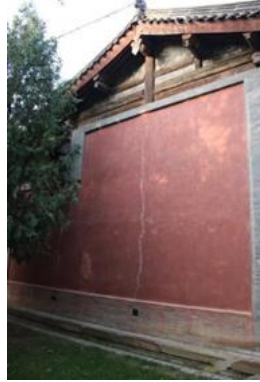
(a) Settlement crack in the east gable and

Fig. 2 Settlement crack diagram

the foundation of the wall all have different degrees of settlement, as shown in Figure 2. However, except for the serious local settlement of the rear hall and the wall, the settlement in other areas is relatively slight. According to the principle of "minimum intervention" in cultural relic restoration, only the local foundation of the rear hall and the wall with serious settlement should be strengthened.

The ground on the south side of the building due to long-term flooding subsidence, resulting in uneven settlement on both sides of the building (the south side is larger, the north side has no settlement), vertical cracks appear from bottom to top at the gable spine, the widest crack is 42mm, and the five beams connected with the spine mortise and tenon have appeared larger tenon phenomenon, endangering the safety of the wooden structure. The original foundation type of the proposed structure is reinforced concrete strip foundation, and there is no treatment of the underground loess silt soil layer. Because the loess silt in this site is collapsible loess, the collapsibility grade is IV self-weight collapsibility, and the maximum collapsibility depth is 21.0m. According to the second paragraph of Article 6.1.1 and the third paragraph of article 6.1.5 of the existing Building Code for Collapsible Loess Area GB50025-2004, part of the collapsible amount of the foundation should be eliminated for Class C buildings on the site, and the remaining collapsible amount of untreated collapsible yellow soil in the lower part after treatment should not be greater than 200mm. According to the calculation, the thickness of the treatment according to the requirements of the code is 15.0 meters. Because the building is a cultural heritage site, the foundation treatment process of dynamic compaction and compacted pile cannot be realized. Therefore, the existing building foundation is treated with slurry method according to the "Building Code for collapsible Loess Area" GB50025-2004, and strict waterproof measures are taken around it. Prevent the existing building from settling again.

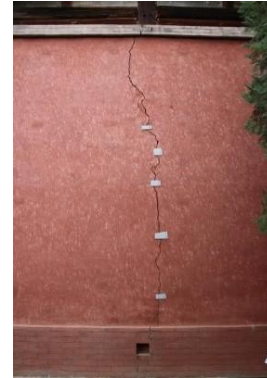
(b) settlement crack in the west gable

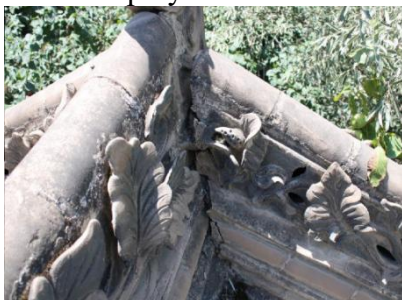
(a) Cracked roof ridge

Fig. 3 Details of the roof

The roof is mainly composed of a wooden base, a tarpaulin back, a ridge, and tiles. Wooden base layer method: if the rafters are split by flying, they should be $\leq 5\text{mm}$, and if the oil or white is broken, they should be filled tightly with putty. If the thickness is greater than 5mm, dry old wooden strips should be used for patching, and epoxy resin adhesive should be used for bonding. After the adhesive is dry, the plane should be planed into an arc (flat with square rafters); The parts of the rafters that are slightly damaged by insects should be cut and scraped clean for anti-corrosion and insect prevention treatment (using ACQ-D wood anti-corrosion and insect prevention agent); When the depth of rafter flying debris is $\leq 5\text{mm}$, it should be tightly applied with putty along with oil decoration or broken white. When the depth of rafter flying debris is $>5\text{mm}$, it should be restored and treated with anti-corrosion according to the specific situation; According to the current material and specifications, replace the damaged and decayed eaves and tile openings, and treat the rafters with flying cracks, rain stains, decay, and insect infestations before making them white. Method of covering the back: 15mm thick hemp knife protective board ash \rightarrow 80mm thick mixed with plaster back \rightarrow 40mm thick tile base slurry mud \rightarrow apply "tie shoulder ash" on the ridge \rightarrow fix the tile and press the shoulder, catch the joint and clamp the ridge; The construction method of the roof from bottom to top is as follows: rafters \rightarrow cover plate (20mm thick, 200mm wide) \rightarrow flying rafters covered with back (15mm protective board ash and 80mm mixed with plaster from cover plate to top) \rightarrow tiled roof (100:3 small hemp knife ash), and the tile construction method is "6 pressed and 4 left"; According to the size and specifications of existing tiles, hooks, and animal parts, restoration cracked, lost, detached, inconsistent tiles, hooks, animal parts, and detached ridges; Remove the tiles and spray them with a 3% hexazine solution.

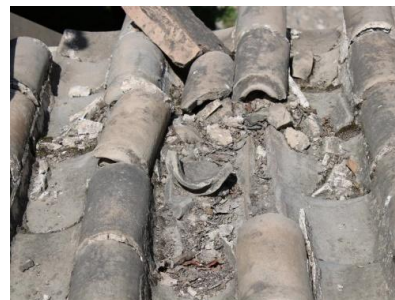
(b) damaged tile surface

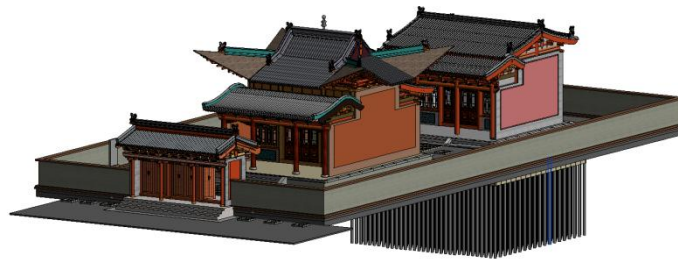
Fig. 4 Cloud picture of Tianqi Temple

In the actual process of renovation, the basic principles of minimal intervention, no change in the original state of cultural relics and reversibility were strictly followed. The project was modeled with Revit as the main body and assisted by Lumion, FZUOR, pr and other software to transform ancient buildings into interesting digital works. Three-dimensional models are used to display the image of ancient buildings, as shown in Figure 4. It has played a very important role in the renovation and later protection of cultural relics, and successfully completed the construction task, and the final restoration effect is ideal, and the overall effect meets the design requirements. It retains the original architectural style of Tianqi Temple and eliminates the hidden safety risks of the building.
